THE SPANISH ACQUISITION

The odds were heavily stacked against German Matthias Boller when he took on a part-restored Authi Mini 1275 GT with plans to rebuild it using only genuine Spanish parts.

1971 Authi Mini 1275 GT

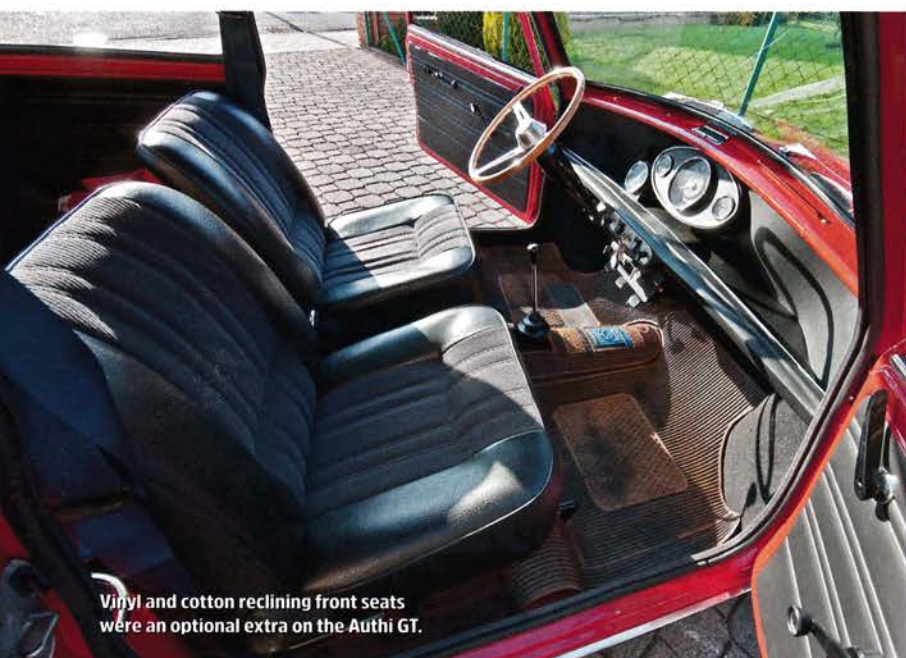
Vinyl and cotton reclining front seats were an optional extra on the Authi GT.

Built on the 17 November 1971 and registered in Madrid, on 2 February 1972, the Authi seen here was originally ordered with recliner seats rather than the standard 1275 GT non-recliners. It wasn't until 1973 that recliners became standard in the Authi Cooper 1300, which had replaced the 1275 GT in the same year.

The first challenge was to find out which parts he had and which were missing. With no manuals or documentation available, research was time-consuming and difficult. However, in some cases, he could simply overhaul parts, as he explains. "I started with the seats. I removed the original seat covers, removed the rust from the seat frames and repainted them. Then I changed the

seat base and installed new seat foams. I cleaned the covers and refitted them."

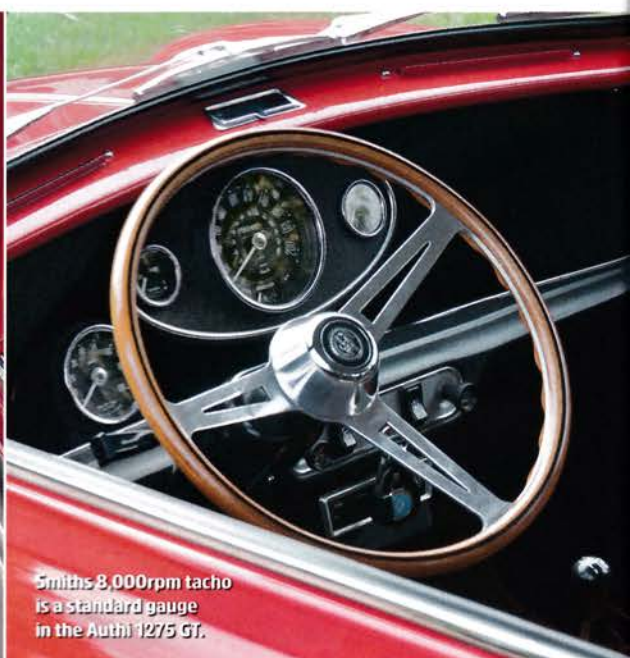
Smiths 8,000rpm tachometer is a standard gauge in the Authi 1275 GT.

The Smiths instruments had already been professionally overhauled together with the factory installed rev counter. "The wooden steering wheel is original Authi," he says. "The clear lacquer was peeling off and it was very worn. I sanded down all the old paint and polished the spokes, boss and horn push. I painted the wood rim with several layers of two-pack clear lacquer and finally polished it until it was smooth."

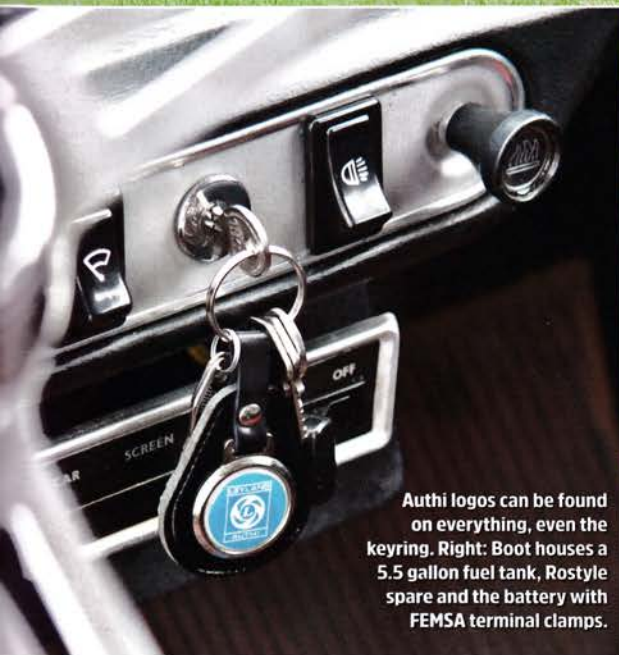
Authi logos can be found on everything, even the keyring. Right: Boot houses a 5.5 gallon fuel tank, Rostyle spare and the battery with FEMSA terminal clamps.

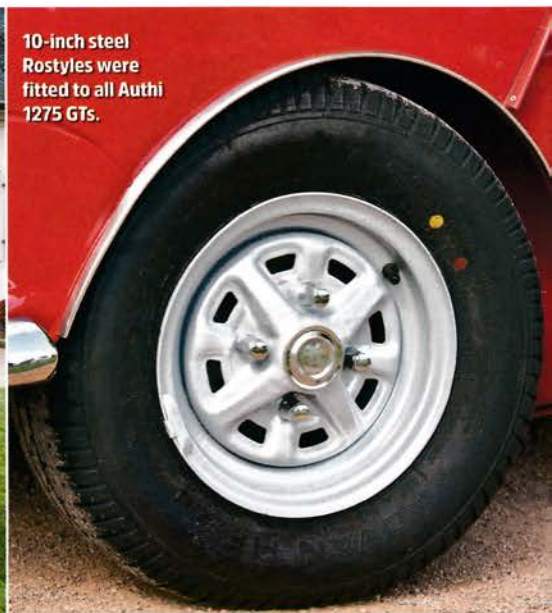
10-inch steel Rostyles were fitted to all Authi 1275 GTs.

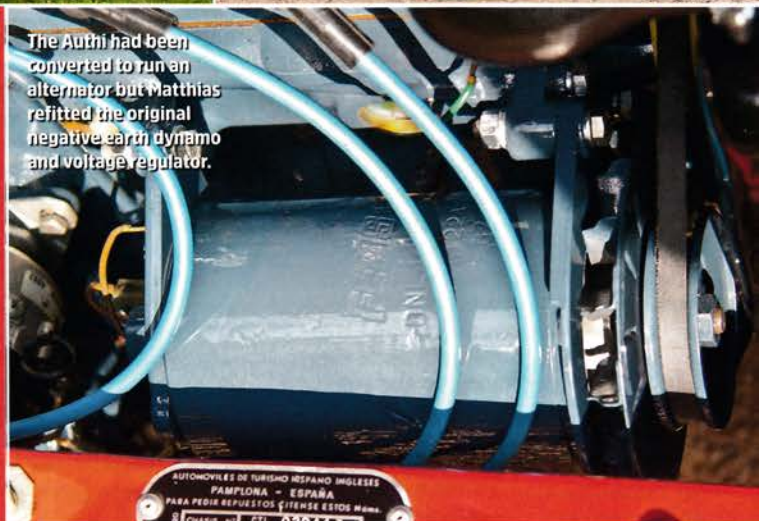
The Authi had been converted to run an alternator but Matthias refitted the original negative earth dynamo and voltage regulator.

In the engine bay, he reinstalled the original wiring loom but noticed the dynamo and voltage regulator had been replaced by an alternator. In the boxes that came with the car, there was an original new old stock FEMSA voltage regulator but no dynamo. With no original wiring diagrams, Matthias could only refer to his Portuguese Mk1 Mini, which is also fitted with a FEMSA

dynamo and voltage regulator. Sadly, the MK1's braided loom was difficult to understand, so he resorted to starting from scratch and making up each individual wire for the conversion back to a negative earth dynamo and regulator.

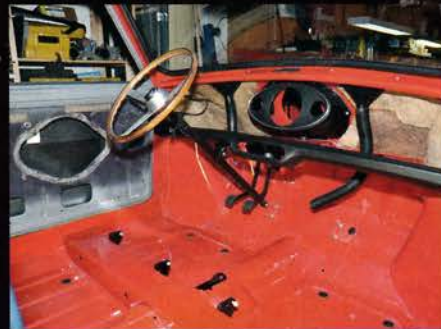
This is how Matthias bought the Authi Mini: the stripped, restored and painted bodyshell was ready to be reassembled when he acquired the project.

"The body was on its wheels with the axles installed," Matthias remembers on first seeing his new project. "Everything else was in boxes. Some of the interior and exterior parts were new, others used. The Hydrolastic suspension, brakes and steering rack were already refurbished. The whole drivetrain was just oily and dismantled and needed a complete overhaul."

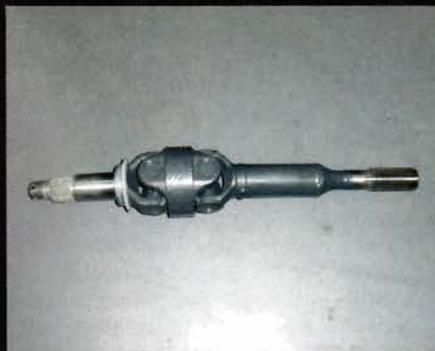
These special Hardy Spicer outboard joints were standard equipment on the Authi Mini driveshafts.

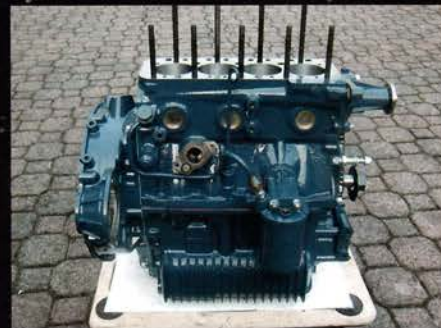
Spanish-manufactured A-series has been bored to 1293cc and painted in original colour blue/grey.

The Authi's 1275cc A-series engine and four-speed manual gearbox had been manufactured by NMQ and the logo can be found on casings and parts ranging from the oil pump and camshaft to the crankshaft and cylinder head. After stripping down the engine and checking, it was found to be in need of a rebore of +0.020-inch, displacing 1293cc.

Once the engine and gearbox were complete, the next challenge was to find the correct Authi paint colour for the power train. From the remains that were on the block, he identified the correct colour as blue/grey RAL5008. "I stuck the whole engine together without gaskets for painting," he says. "Then all the parts had to come off again to do the final assembly, including gaskets." »

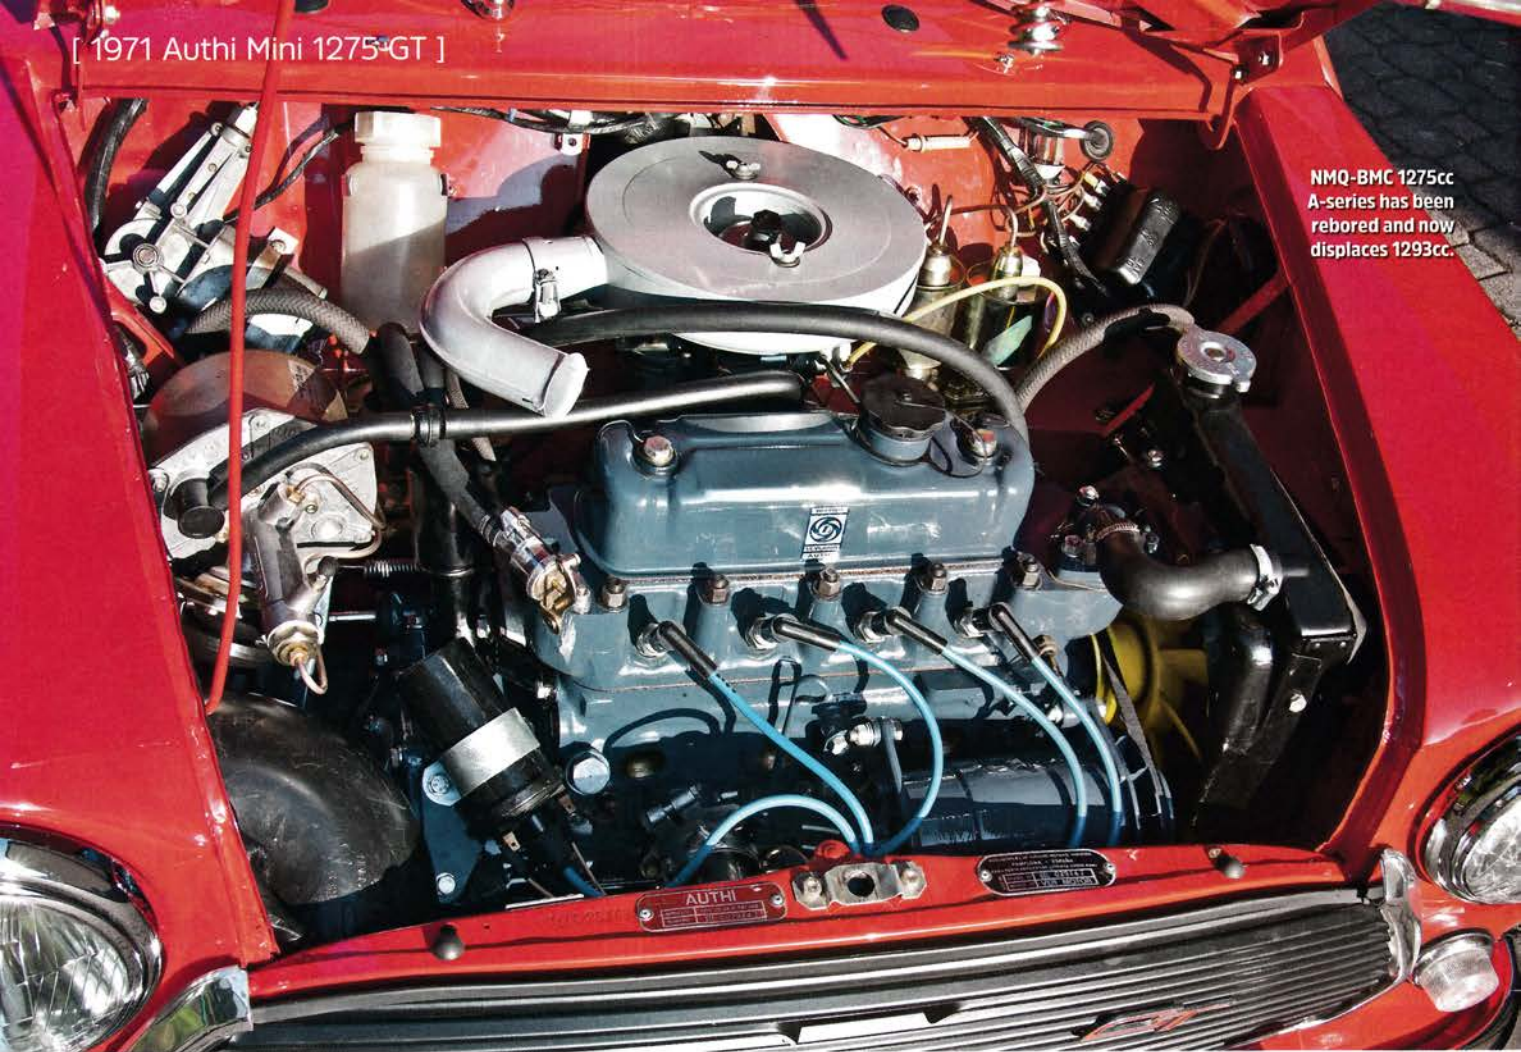
NMQ-BMC 1275cc A-series has been rebored and now displaces 1293cc.
